# **A Study of Air-Gap Breakdown at 28.5 Kilohertz**

F. Ralph Kotter

June 20, 1975

Prepared for  
**U.S. Naval Electronic Systems Command**  
**Code PME-117-1022**  
**Washington, D. C. 20360**

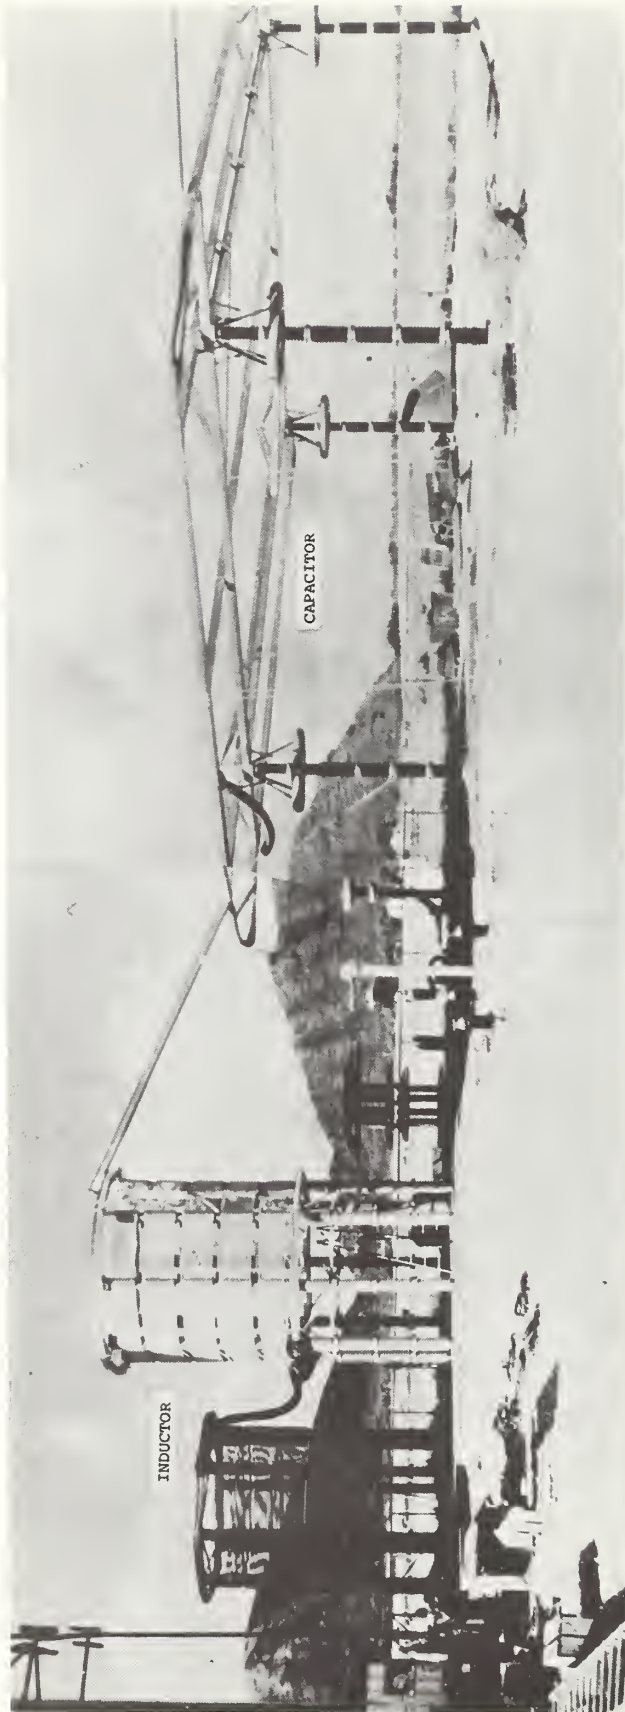
Figure 1 Outdoor Portion of VLF Test Facility at NRTF  
Lualualei, Oahu, Hawaii

The work herein reported was made possible by the existence of the excellent test facility constructed adjacent to the helix house of the VLF transmitter at the Naval Radio Transmitting Facility (NRTF), Lualualei, Hawaii. Designed by A. N. Smith of the Navy Electronics Laboratory Center (NELC), San Diego, California, and constructed and operated under his direction, this versatile facility utilizes the transmitter as a power source and the inductors and variometers in the helix house as the fine tuning elements of a resonant circuit which also includes the capacitor and inductor shown in Figure 1. A detailed description of this facility is to be given in a forthcoming NELC report.

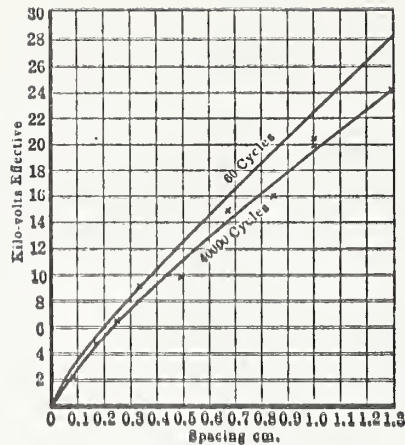
Figure 2—Sphere gap spark-over voltages at 60 cycles and 40,000 cycles.  
(From Peek<sup>1</sup>)

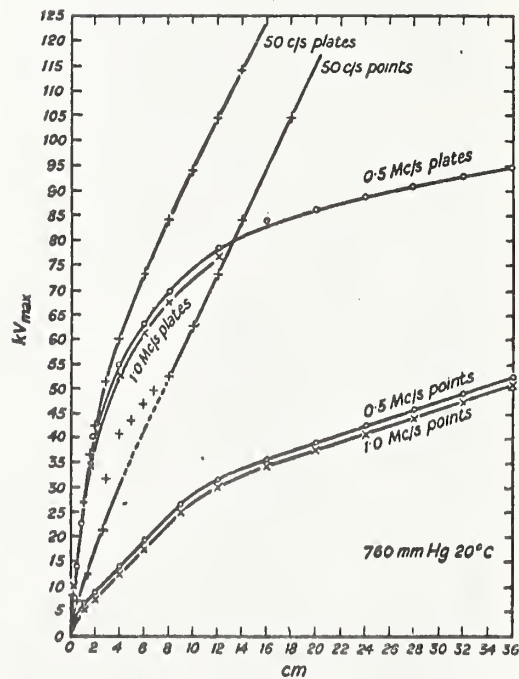
Figure 3. Breakdown voltage in air at atmospheric pressure as a function of gap length between plates and between points for frequencies of 50 c./s., 0.5 Mc./s. and 1.0 Mc./s. (From Meek and Craggs<sup>2</sup>)

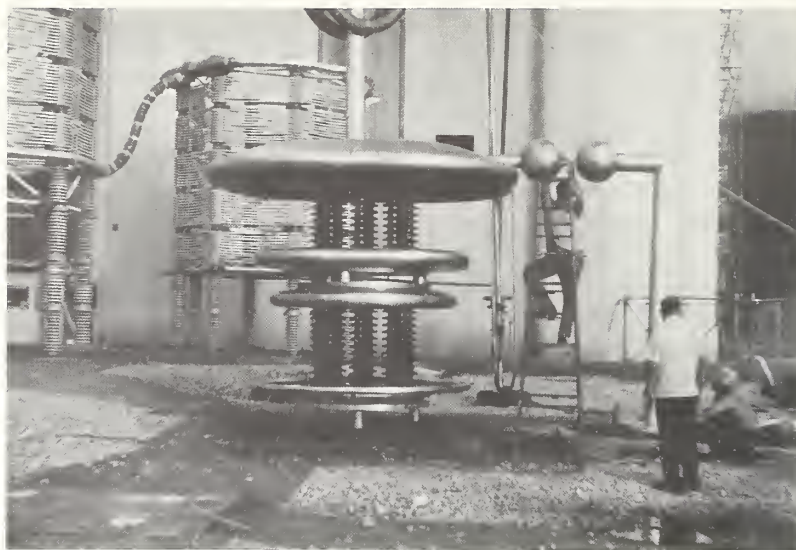
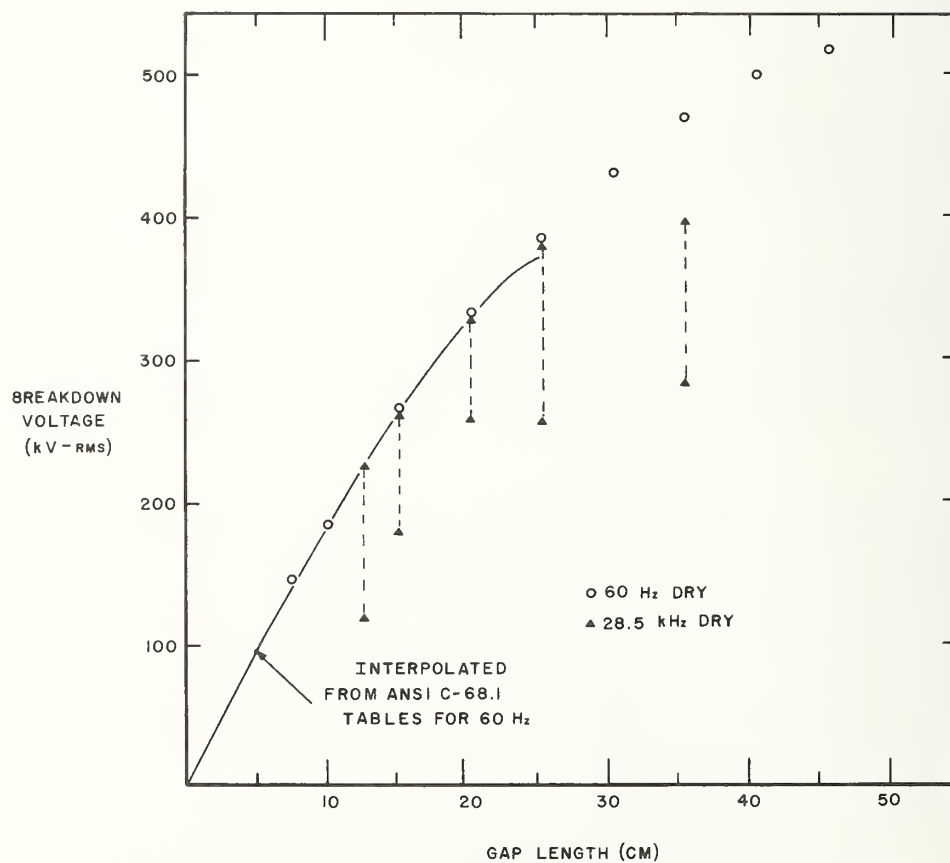
FIGURE 5 PROTECTIVE GAP, 45.7-CM (18-INCH) DIAMETER SPHERES  
(A) MOUNTING ARRANGEMENT, (B) BREAKDOWN CHARACTERISTICS

The results obtained with an 18" (45.7 cm) sphere gap mounted as shown in Figure 5 (a) are given in Figure 5 (b). The solid curve was obtained by interpolation from the internationally accepted standard sphere gap tables (ANSI Standard C68.1 and IEC Pub. 52). The agreement with the standard curve is somewhat better than might have been expected since the restrictions on the proximity of the supporting structures specified in the ANSI Standard were not met.

The 60 Hz data points represent the mean of at least three successive trials for which the spread in the values obtained was less than 1%. At the VLF frequency (28.5 kHz) the scatter in the breakdown values at a given spacing was quite large. The data points plotted show the extreme values observed. Of significance is the fact that at the 25-cm spacing two of the five trials resulted in flashovers from the base-insulator top rainshield about 2.5 meters to the ground plane without involving the sphere gap. The other three were flashovers in the gap. At the 36-cm spacing all except two of the five trials resulted in flashovers from the rainshield to ground rather than in the gap. Only gap flashover values are shown in Figure 5.

There is no pre-breakdown corona discharge in a relatively small gap between two large spheres. Thus the development of sufficient space charge to significantly distort the field must depend upon stray ionizing radiation. The experimental results indicate that the probability of such space charge development during the time interval in which the voltage is being raised toward the undistorted-field breakdown value is significant although not high.

These tests appear to indicate that there was a greater probability of space-charge development initiated by corona discharges from electrode imperfections or from nearby structures or by other stray ionization sources in the 2.5-m gap between the rainshield and the ground plane than in the 0.36-m gap between the spheres.

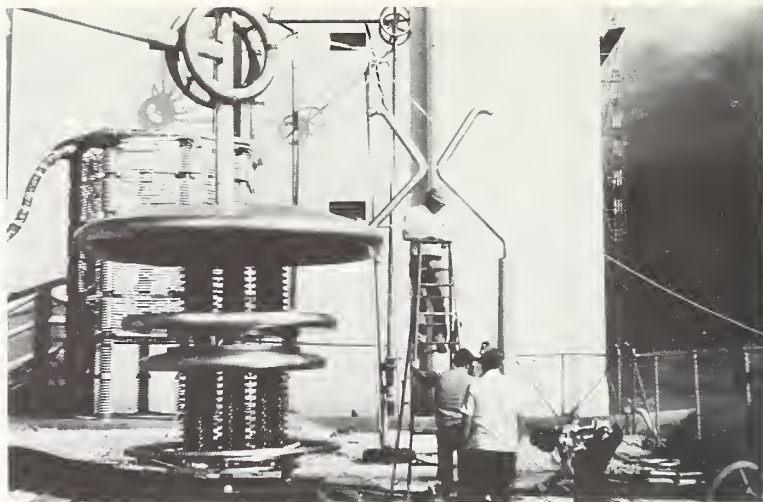
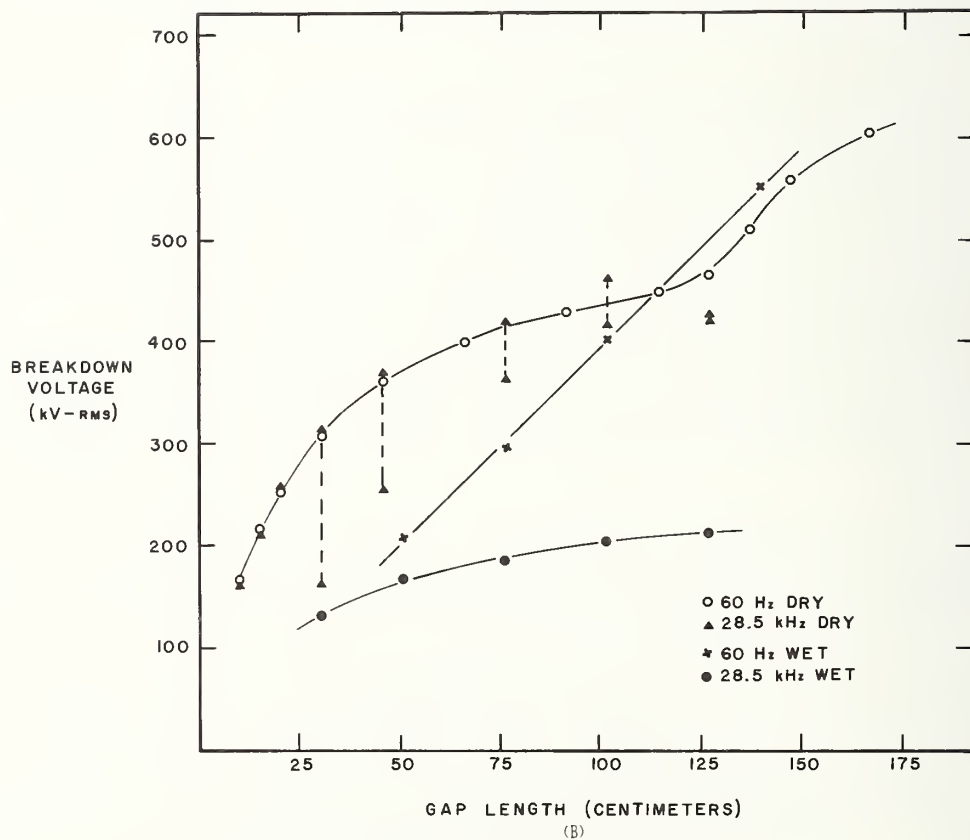
FIGURE 6 HORN GAP: (A) MOUNTING ARRANGEMENT, (B) BREAKDOWN CHARACTERISTIC

A horn-gap configuration was also studied both at 60 Hz and at 28.5 kHz. The electrodes were constructed of 4" (10-cm) diameter aluminum tubing bent and mounted as shown in Figure 6 (a). The results obtained are plotted in Figure 6 (b). Each data point shown for the 60 Hz experiments represents the average of at least three trials with mean deviations of less than 3%. The scatter in the dry 28.5 kHz test data was quite large; however, all the data obtained for flashovers in the gap fell within the ranges shown on the figure. Not indicated on the figure were several flashovers which occurred from the high voltage electrode or the top rainshield to the ground plane or ground electrode rather than in the gap during dry 28.5 kHz testing at gap settings of 75 cm and larger.

The behavior of the horn-gap configuration was investigated under simulated rain conditions with the results also shown in Figure 6 (b). Flashover seemed always to develop from corona streamers originating at water drops on the high-voltage electrode surface and at both frequencies with the larger spacings there were several flashovers to the ground plane rather than in the gap. However, for flashovers which occurred in the gap the consistency was quite comparable with that of the dry 60 Hz data.

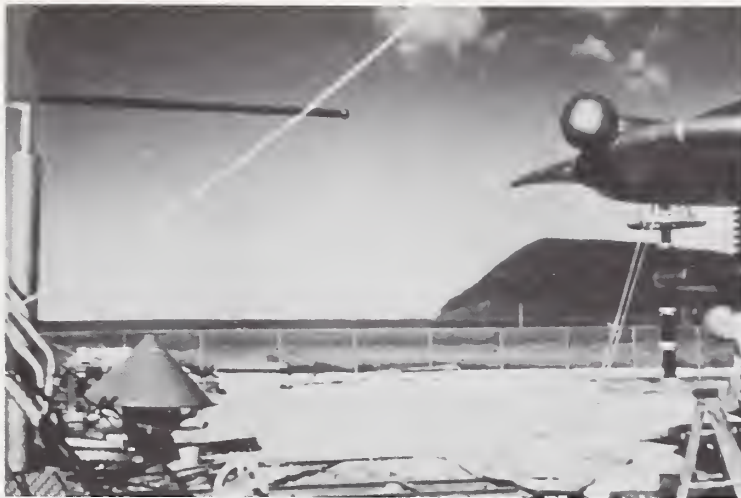
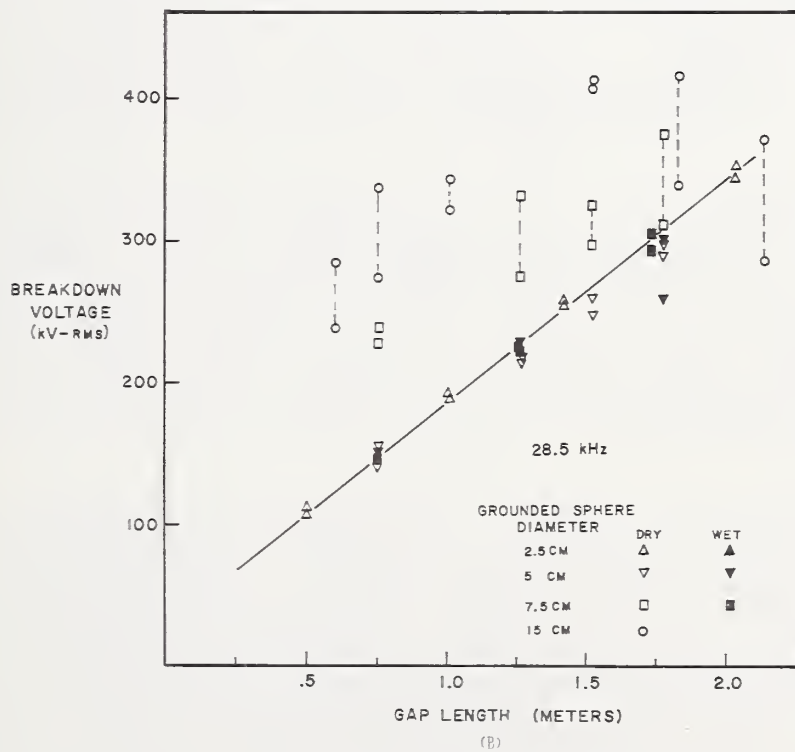
FIGURE 7 PROTECTIVE GAP, ASYMMETRIC SPHERES. (A) MOUNTING ARRANGEMENT. (B) BREAKDOWN CHARACTERISTICS

Several modifications of an asymmetrical sphere-gap system in which the high voltage electrode was one of the 45.7-cm spheres and the ground electrode a much smaller sphere were investigated at 28.5 kHz only. Figure 7 (a) shows a typical arrangement and Figure 7 (b) presents the results.

It is believed that the quite consistent performance exhibited when the grounded sphere was 2.5 or 5 centimeters diameter resulted from an ample supply of ions in the gap. Audible corona from the small ball prior to breakdown was always present. Note that under dry conditions with grounded sphere diameters of 7.5 and 15 centimeters, the scatter in values was comparable to that observed with the symmetrical sphere gap. Under wet conditions where water droplets on the spheres distorted the surfaces, the breakdown voltages appeared to be very nearly independent of the diameter of the grounded sphere.

In the course of the redesign of the base insulator assembly, several different protective gap configurations were studied. Two of them, the 45.8-cm sphere gap and the horn gap were investigated both at 60 Hz and at VLF with the results indicated in Figures 5 and 6. Several gaps in which the electrodes were spheres but of unequal diameters were also investigated at VLF (see Figure 7).

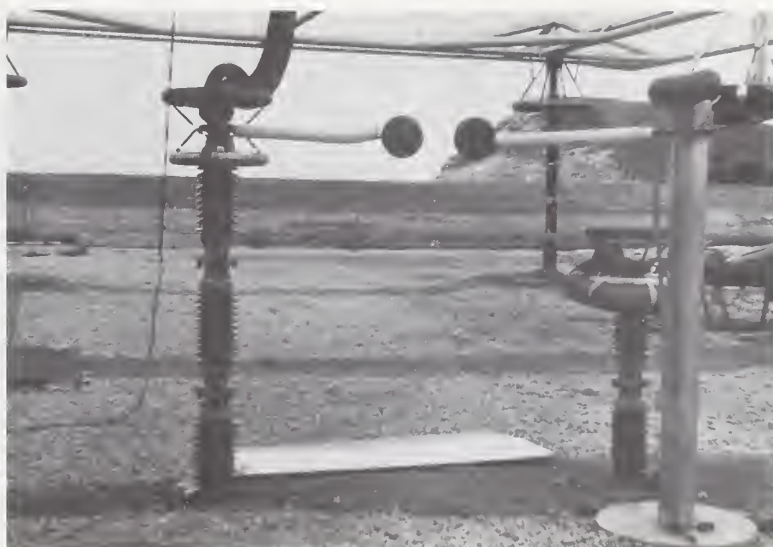
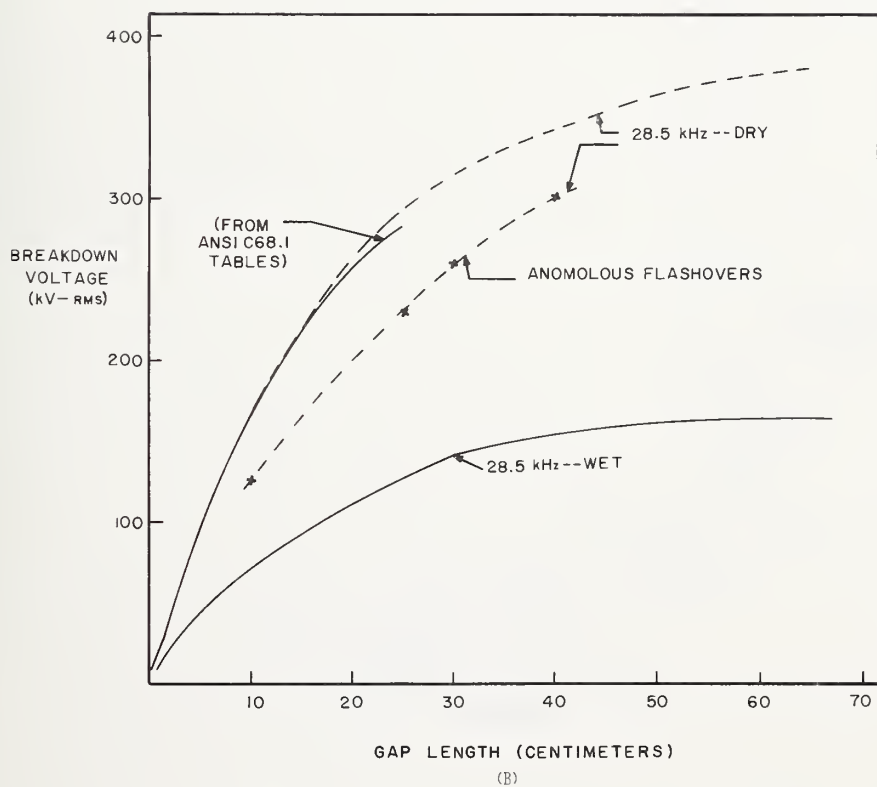
FIGURE 8 25-CM SPHERE GAP: (A) MOUNTING ARRANGEMENT,  
(B) BREAKDOWN CHARACTERISTIC

The 25-cm spheres used were heavy brass spheres with sparking surfaces in excellent condition. Care was taken to make certain the supporting structure met the requirements of the standards documents which apply to the use of sphere gaps as standards for voltage breakdown measurements (ANSI C68.1 and IEC No. 52). The test procedures recommended in the standards were followed as closely as possible. Corrections were applied for relative air density but none for humidity. (See Appendix B). Figure 8 (a) provides the details of the mounting arrangement used and Figure 8 (b) shows the results obtained.

It is significant to note that except for a few anomalous flashovers, attributed to chance space-charge-induced field distortion, the breakdown voltage is the same at 28.5 kHz as at 60 Hz for spacings up to a sphere radius. The radius spacing is the limit for which a sphere gap is recommended as a measuring instrument. The significance of the difference between the 60 Hz and 28.5 kHz curves for larger gap spacing is open to question, since as the spacing is increased the influence of the surroundings becomes more important, and the extent of that influence is not known in either case.

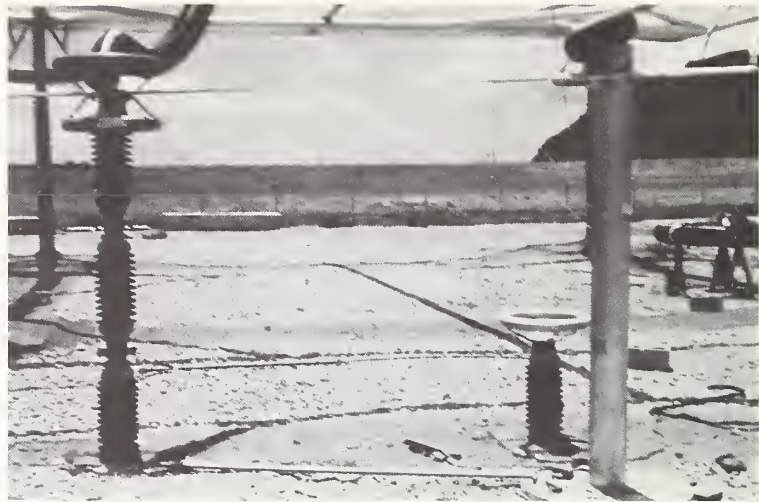
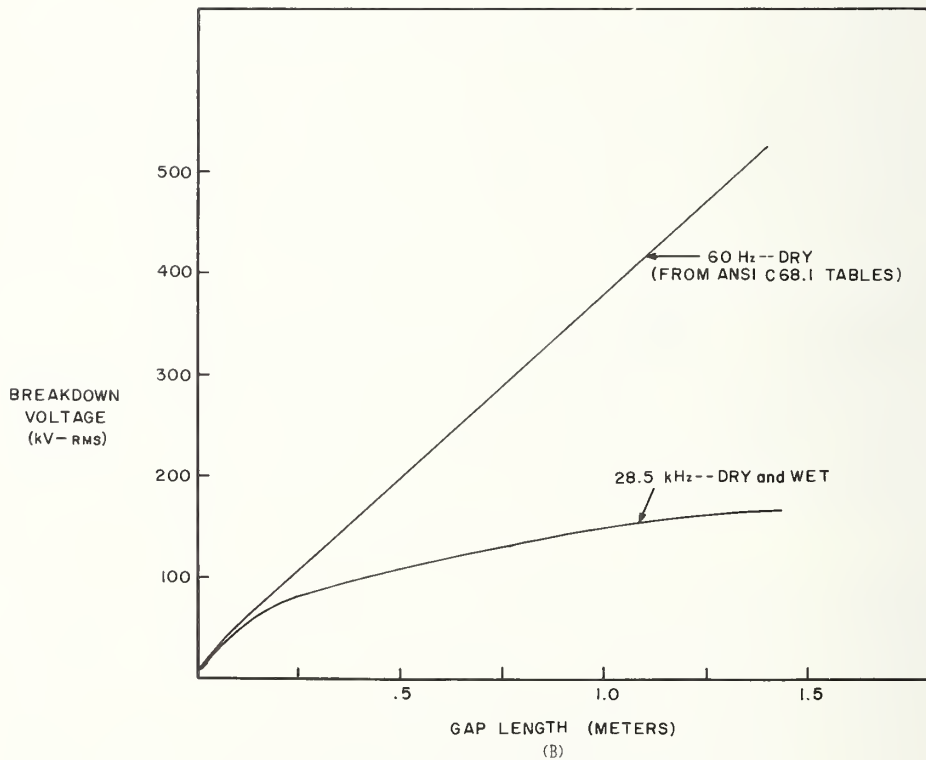
FIGURE 9 "STANDARD" (1/2-INCH SQUARE) ROD-ROD GAP: (A) MOUNTING ARRANGEMENT, (B) BREAKDOWN CHARACTERISTIC

This good agreement between the VLF and 60-Hz performance was not found in the case of "standard" rod gaps as Figure 9 (b) indicates. Figure 9 (a) shows the physical arrangement which met the clearance specifications for a standard rod gap (C68.1, p. 24) up to 1 meter gap length. The reduction in breakdown strength at 28.5 kHz relative to that at 60 Hz increases markedly with increasing gap spacing for gaps more than a few centimeters in length. It appears that the copious supply of ionizing electrons resulting from the corona discharge at the ends of the rods is adequate to produce significant space-charge field distortion.

Over this range of gap settings, the breakdown voltage is demonstrated to be independent of frequency as could have been predicted from the results plotted in Figure 9 which show a marked effect of gap length on the frequency influence.

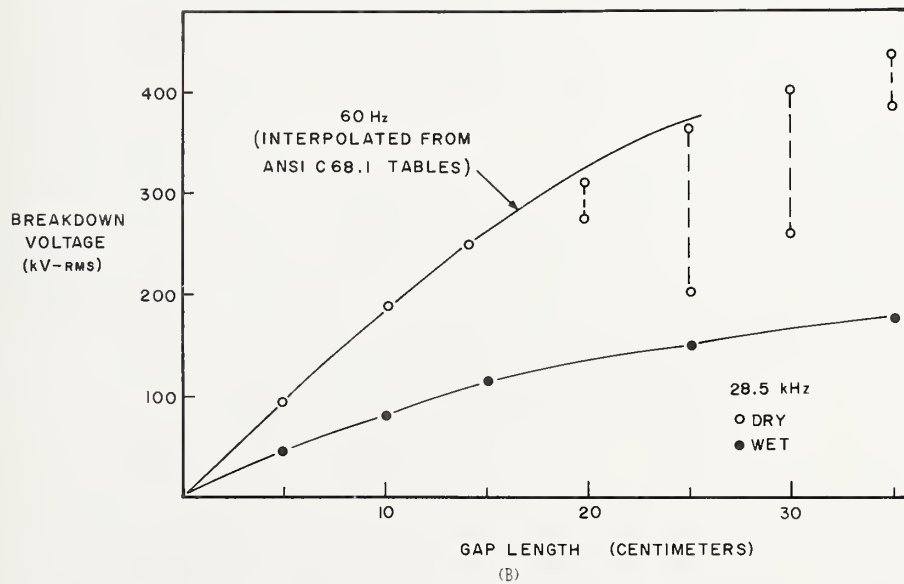
FIGURE 10 45.7-CM SPHERE GAP: (A) MOUNTING ARRANGEMENT,  
(B) BREAKDOWN CHARACTERISTIC

Additional data were obtained for a sphere gap using the 45.7-cm diameter aluminum spheres previously tested as a protective gap. The sparking surfaces of these spheres were in good condition, however, it was not feasible to meet all the standards specifications for mounting them. The mounting arrangement is shown in Figure 10 (a) and the results of the testing are plotted in Figure 10 (b). In view of the fact that the dimensions and spacing of the supporting structures used for the VLF tests did not comply with the standards, the significance of the apparent reduction in the maximum values of breakdown strength at VLF relative to 60 Hz for gap lengths greater than the radius of one of the spheres is open to question. Unfortunately, a test series at 60 Hz with the same physical arrangement was not feasible. However, the results shown in Figure 5 obtained with a mounting arrangement where the influence of the proximity of the supporting structures should have been even more disturbing, lends confidence to the assumption that the interpolated curve for 60 Hz in

Figure 10 (b) is not seriously in error.

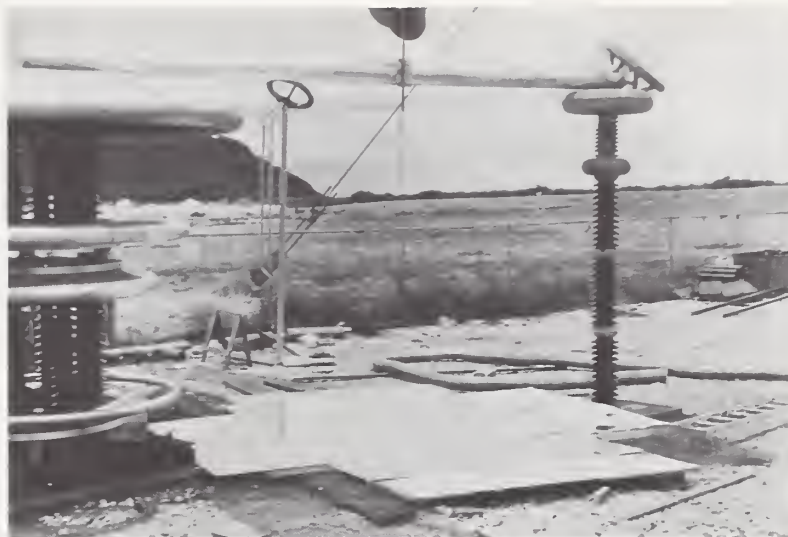
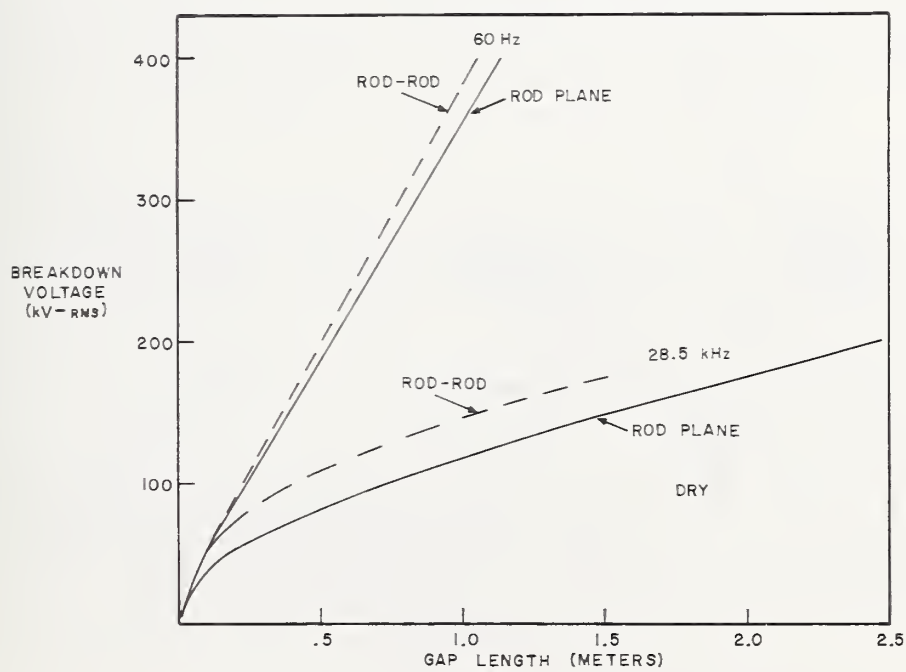
FIGURE 11 "STANDARD" (1/2 INCH SQUARE) ROD-PLANE (A) MOUNTING ARRANGEMENT. (B) CHARACTERISTIC. (ROD-ROD CURVES REPLOTTED FROM FIG. 9 FOR COMPARISON, 60 HZ ROD-PLANE DATA FROM BELLASCHI AND TEAGUE<sup>9</sup>)

VLF breakdown data for several rod-plane and sphere-plane gap configurations were obtained. The physical arrangements and the results obtained are shown in Figures 11 and 12. In those cases where 60 Hz data are available for essentially identical geometries, they are included for comparison.

The rod-rod characteristic could not be extended above about 170 kV since at higher voltages the flashover was preferentially over the longer path from the high voltage rod to the ground plane rather than to the grounded rod. Similar problems set an upper limit to the range of sphere-plane spacings for which data could be obtained. At higher voltages than those shown in Figure 12, the flashover path terminated on the sphere support rather than on the sphere itself. These results, together with those shown in Figure 13 for round rods with hemispherical ends which showed approximately sphere-gap characteristics up to spacings and voltages at which significant pre-breakdown discharges developed, and the "standard" rod-gap results at the higher voltages, are in accord with the space-charge field-distortion theory already discussed.

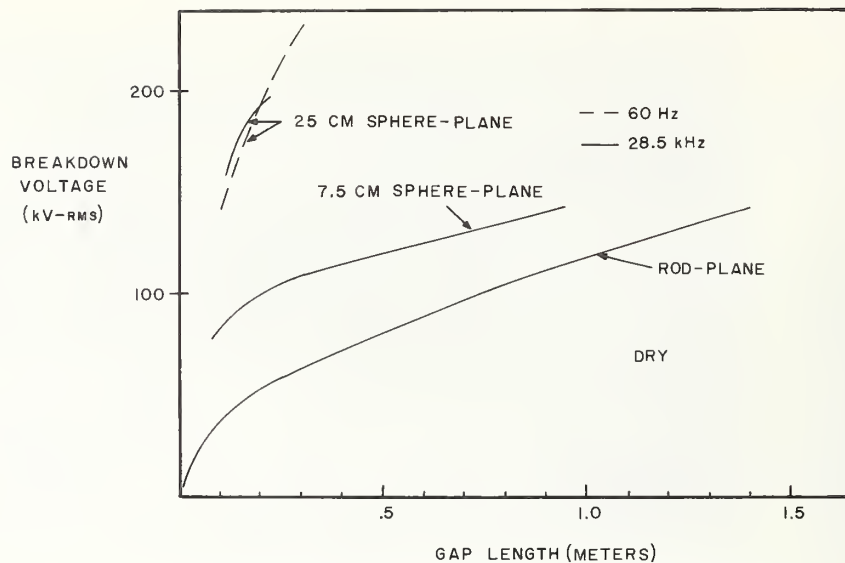
FIGURE 12 SPHERE-PLANE CHARACTERISTICS (ROD-PLANE CHARACTERISTIC REPLOTED FROM FIGURE 11 FOR COMPARISON. 60 HZ DATA FROM BELLASCHI AND TEAGUE<sup>9</sup>)

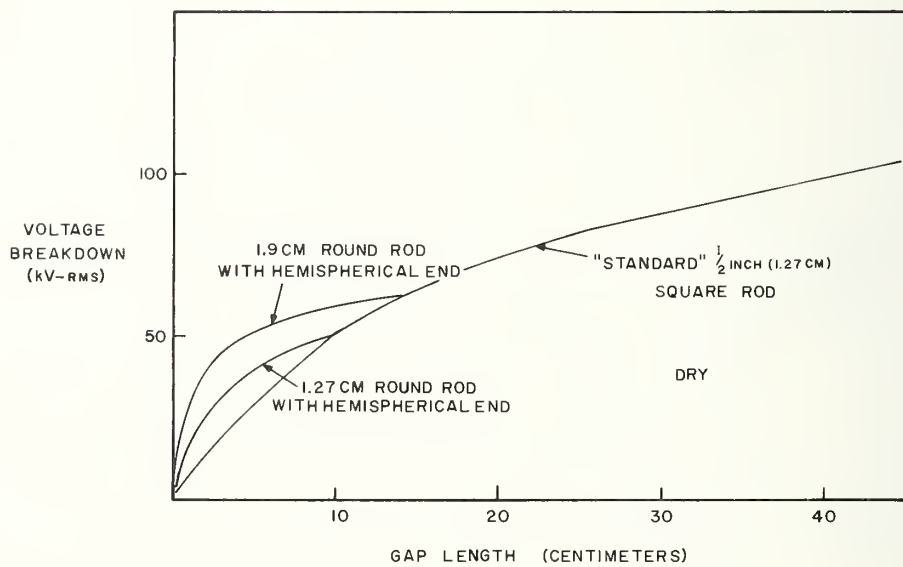
FIGURE 13 EFFECT OF ROD-END GEOMETRY ON ROD-ROD GAP BREAKDOWN CHARACTERISTICS

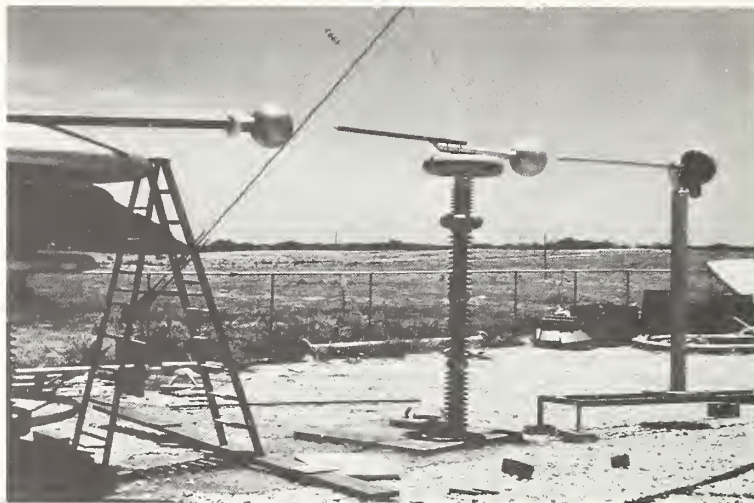
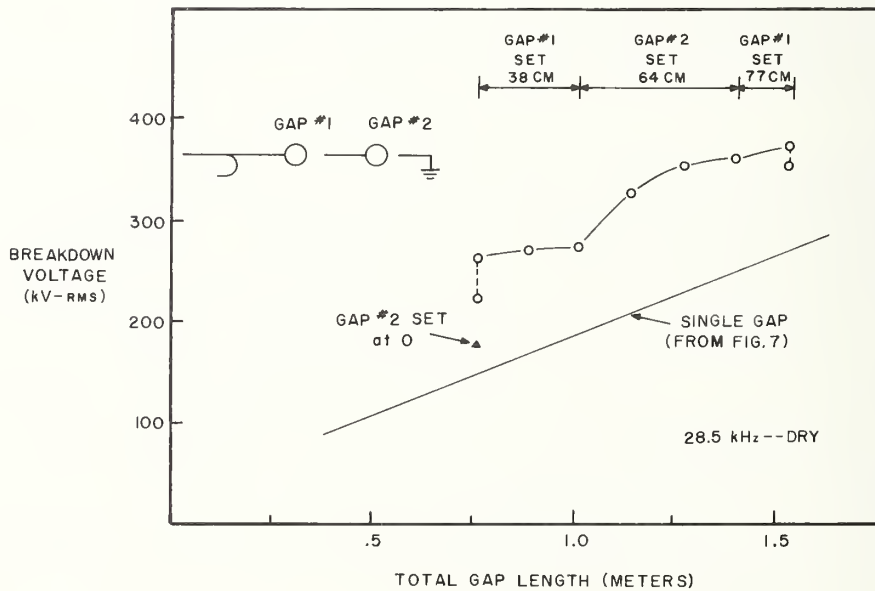
FIGURE 14 DOUBLE ASYMMETRIC GAP ASSEMBLY: (A) MOUNTING ARRANGEMENT, (B) BREAKDOWN CHARACTERISTICS

The performance of the gap assembly consisting of a 47.5-cm diameter sphere as one electrode and a 2.5-cm or 5-cm sphere as the other was such as to nearly meet the requirements and suggested investigation of two such gaps in series. The dry flashover results of this investigation are shown in Figure 14. The limitation appeared to be the radius of curvature of the high voltage electrode which under rain conditions resulted in streamer formation from water droplets. However, all flashovers were in the gaps and, as shown in the figure, it was successfully demonstrated that the breakdown voltage for two such gaps in series is significantly higher than for a similar single gap of equivalent total length. It is believed the fact that the effect on breakdown voltage of the same incremental change in gap length was different for the two gaps resulted from lack of equal division of the total voltage between them. Further study of this configuration was discouraged by the results of a wet test during which there was extensive streamer development from water droplets on the high-voltage sphere at about 250 kV with flashovers occasionally to the ground plane as well as across the gap assembly.

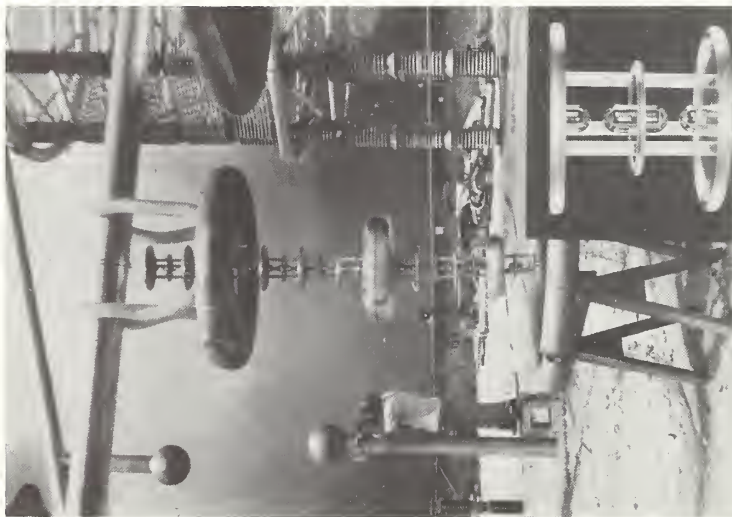
Figure 15 Prototype uniform-field multiple-gap assembly. Inset shows single section.

Several versions of a multiple-gap assembly have been studied. The first of these, shown in Figure 15 consisted of short gaps between hemispherical electrodes. Under dry conditions the performance of this array with VLF appeared to be entirely satisfactory; however, rain droplets on the hemispheres seriously reduced the flashover level. An array which exhibited very nearly the same flashover values either wet or dry is that shown in Figure 16. The performance of such a system is highly dependent on the degree of uniformity achieved in distributing the total voltage over the individual gaps in the array. However, even when these efforts were only partially successful the overall performance of the assembly proved satisfactory at VLF.

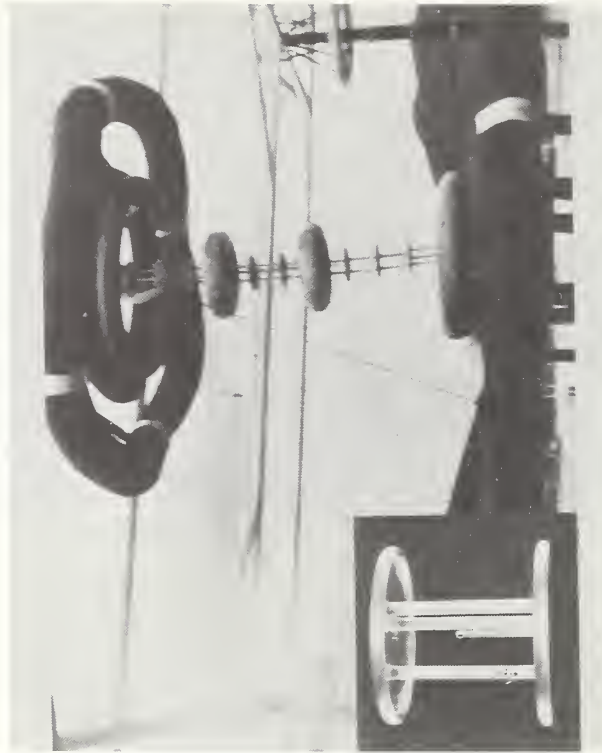
Figure 16 Prototype rod-plane multiple-gap assembly. Inset shows single section.

The effect of variations in the radius of curvature of the rod end was also studied using a single section (Figure 16) with the results shown in Table 2.

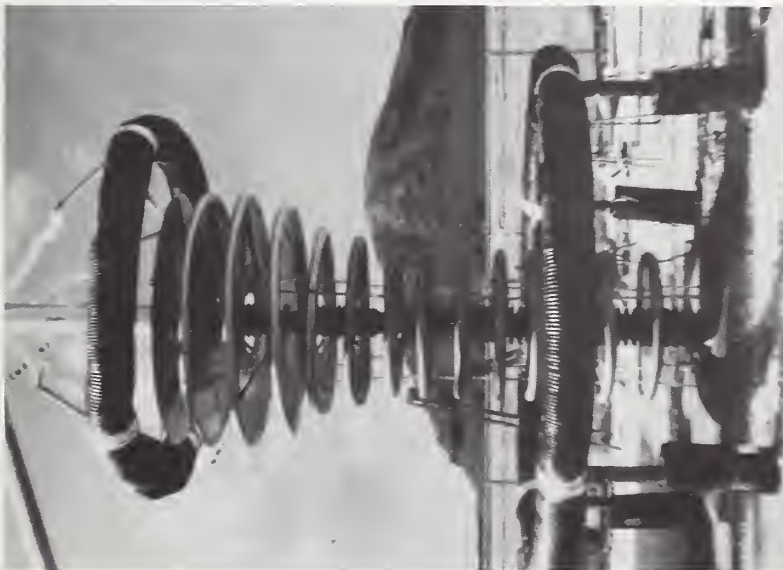
Figure 17 Multiple rod-plane gap assembly

The improved version of this rod-plane multiple-gap assembly (Figure 17), which had more nearly uniform voltage distribution and in which some adjustments were made in individual gap lengths in an attempt to compensate for the nonuniformity which remained, provided quite acceptable performance as shown in Table 1.

TABLE 1  
Flashover Voltage of  
Rod-plane Multiple-Gap Assembly  
Shown in Figure 17

While it was not feasible to attempt impulse testing of the gap assembly shown in Figure 17, a quite similar assembly which used most of the same components and for which very nearly identical VLF performance could be expected was tested at the Patuxent River Naval Air Test Center facility in March 1975 following the procedures outlined in ANSI C68.1. The results of those tests together with comparative data for the Continental Base Insulator Assembly (CBIA) obtained at the A. B. Chance Laboratory in August 1974, are shown in Table 4.

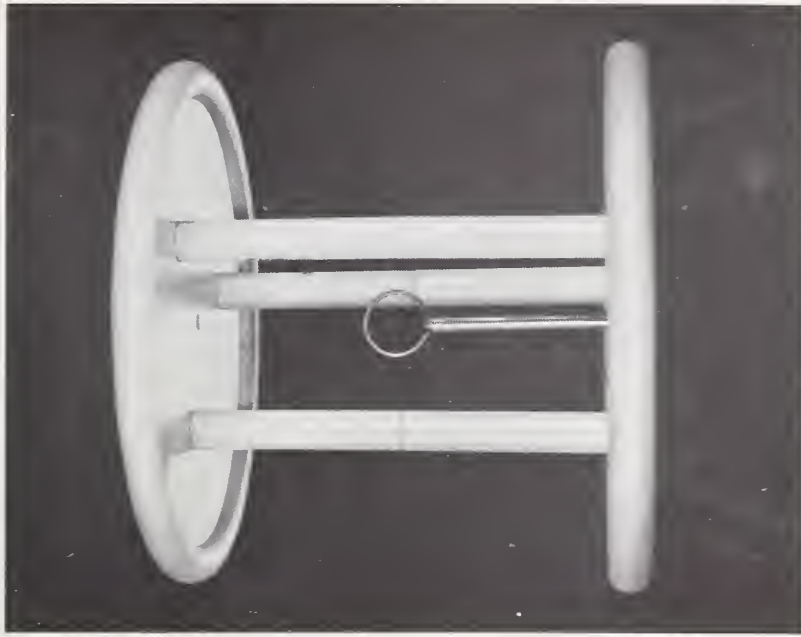
Figure 18 Rod-ring gap

Since a degree of shielding from the rain is provided by the gap arrangements of Figure 18 and since water would drop from the bottom of a ring mounted as shown, whereas the expected sparking point is at the top, a 8.4-cm gap of that design (Figure 18) was tested dry both at 60 Hz and at 28.5 kHz with the results shown in Table 3.

As shown in Table 2, the breakdown voltage for the same length gap with a 1.3-cm hemispherically ended rod is about 40 kV. Thus the ring-plane gap exhibits a breakdown value at 60 Hz well over twice that for the rod-plane gap in confirmation of the findings of Cookson and Farish. However, since the breakdown voltages for the rod-plane and ring-plane gaps are not significantly different at 28.5 kHz it appears that the ultra-corona type of discharge either does not exist or simply does not influence the breakdown at VLF.

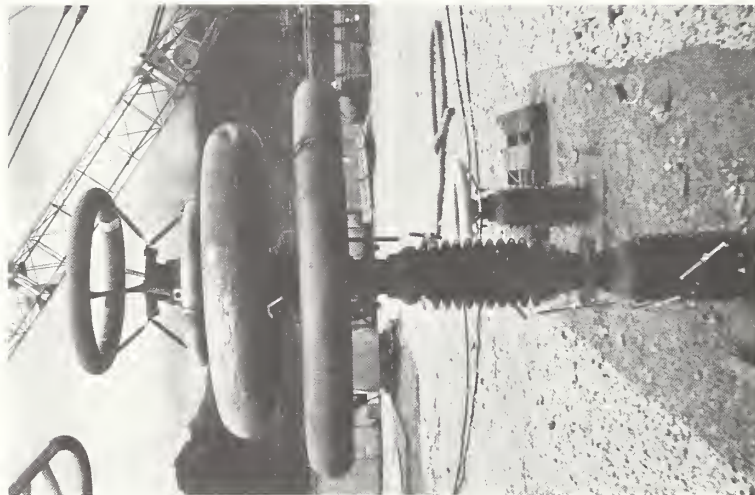
Figure 19 Single post rod-rod multiple-gap assembly

The rod-rod gap assembly shown in Figure 19, consisting of ten 6.4-cm gaps, exhibited at 28.5 kHz a dry flashover value of 261 kV and a wet flashover of 218 kV. However, the flashovers under wet conditions were all from the grading ring to ground. It appeared that had time permitted, an assembly of such gaps on a taller structure with more care taken in the design of the grading ring would have shown satisfactory performance at VLF.

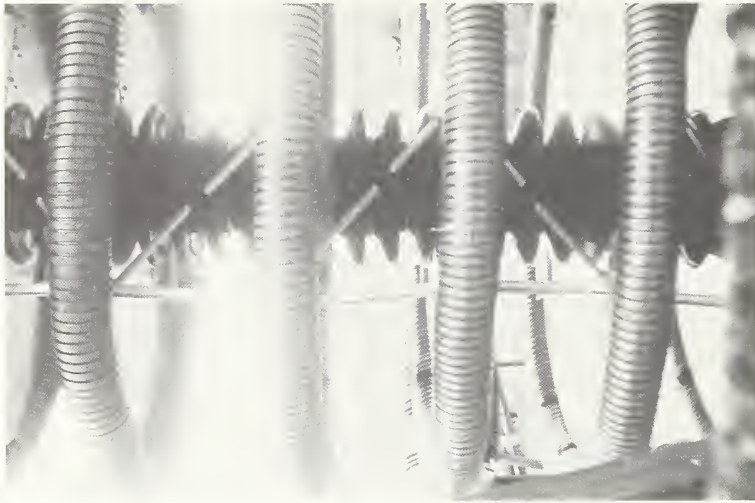
Figure 20 Assembly of Figure 17 modified to incorporate rod-rod gaps

An attempt to evaluate the rod-rod concept at VLF with improved field grading was made by installing a rod gap such as shown in Figure 20 in each section of the assembly of Figure 17. This, however, proved unsuccessful in that with the fourteen gaps required, the spacing of each gap could be only of the order of 2.5 centimeters. At that spacing it appeared that periodic bridging of one or more of the gaps by a water stream occurred in the heavy rain tests and the performance became erratic.
